Blower door tests of a group of identical flats in a new student accommodation in the Arctic

Kotol, Martin; Rode, Carsten; Vahala, Jan

Kotol, M., Rode, C., & Vahala, J. (2012). *Blower door tests of a group of identical flats in a new student accommodation in the Arctic*. Paper presented at 33rd AIVC conference – 2nd TightVent conference, Copenhagen, Denmark.

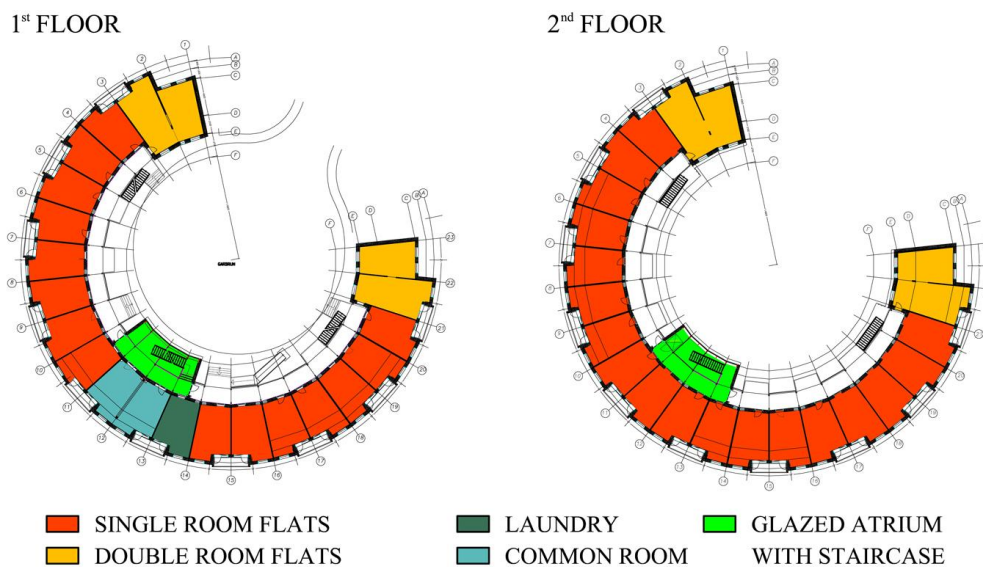
The floor plan of the building has the shape of an open circle, and has a partially heated ground floor and two upper floors. A main technical room and janitor's office are in the heated part of the ground floor and small storage compartments for each flat are in the unheated part together with small technical rooms with ventilation units. The 1st and 2nd floor consist of 33 identical single room flats, and four double room flats at the gables of the building. In addition, there is a common room with a kitchen and a laundry room on the first floor (Figure 1 shows the floor plans). In the second floor, the common room and laundry is replaced with single room flats. There is also a glazed atrium with a staircase in the centre of the building. Each single room flat has a total floor area of 23 m^2 and consists of an entrance (3.3 m^2), a bathroom (2.8 m^2) and a living room with a kitchenette (16.8 m^2). The double room flats have a floor area of 50.2 m^2 . All living units have a small balcony.

Figure 1. Floor plans of Apisseq

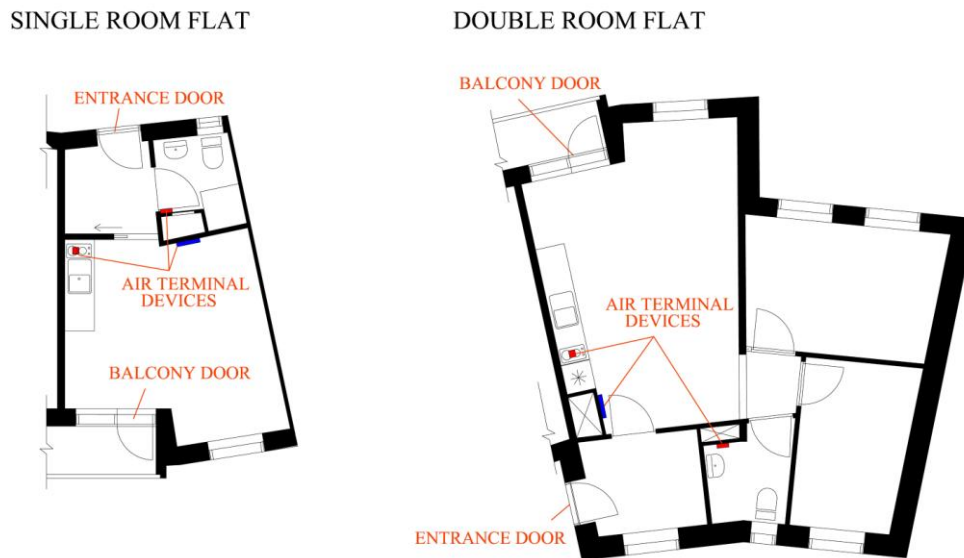
The drawings of typical single and double room flats are shown in figure Figure 2 and the values used for the calculations are summarized in Table 1.

Figure 2. Drawings of the flats

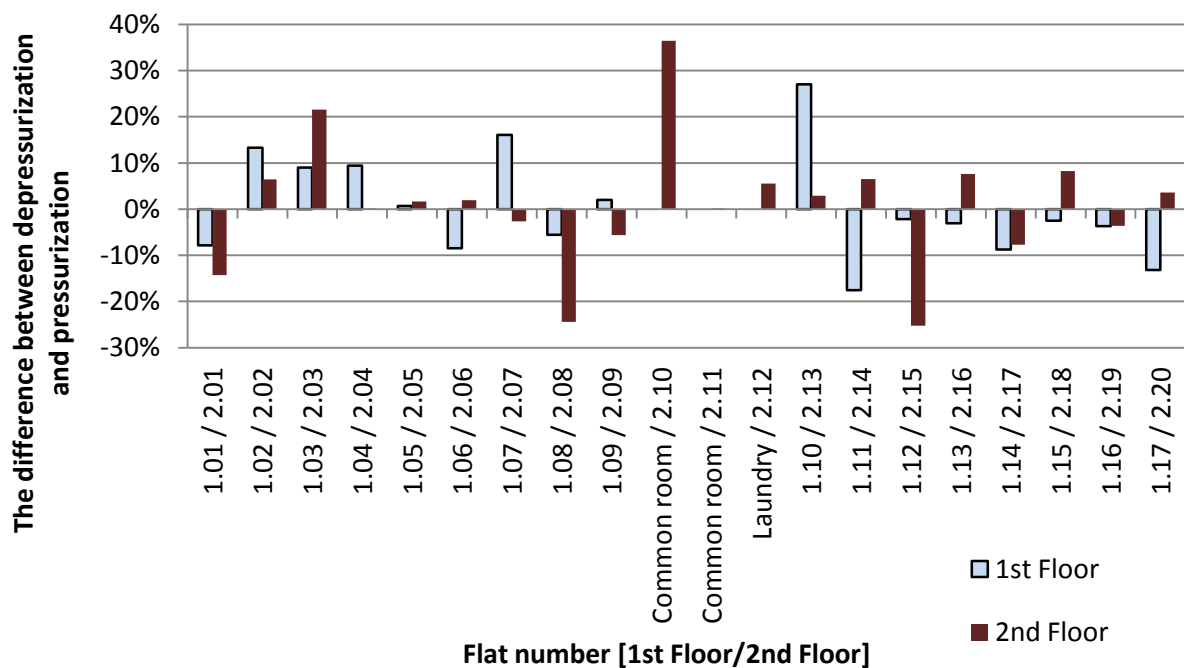
The correlation factor is, except for three measurements, always higher than 95%. Only depressurization of flats 1.07 and 1.12 and pressurization of flat 1.10 is between 92% and 95%. The differences between pressurization and depressurization tests (see Figure 3) are on average 9.1%. When comparing the positive and negative differences, a two sample t-test

yields a P-value of 0.95 which indicates that there is no prevalent trend of one of the tests (pressurisation or depressurisation) giving constantly higher or lower result.

Figure 3. Negative values mean that the result from pressurization was larger than from depressurization

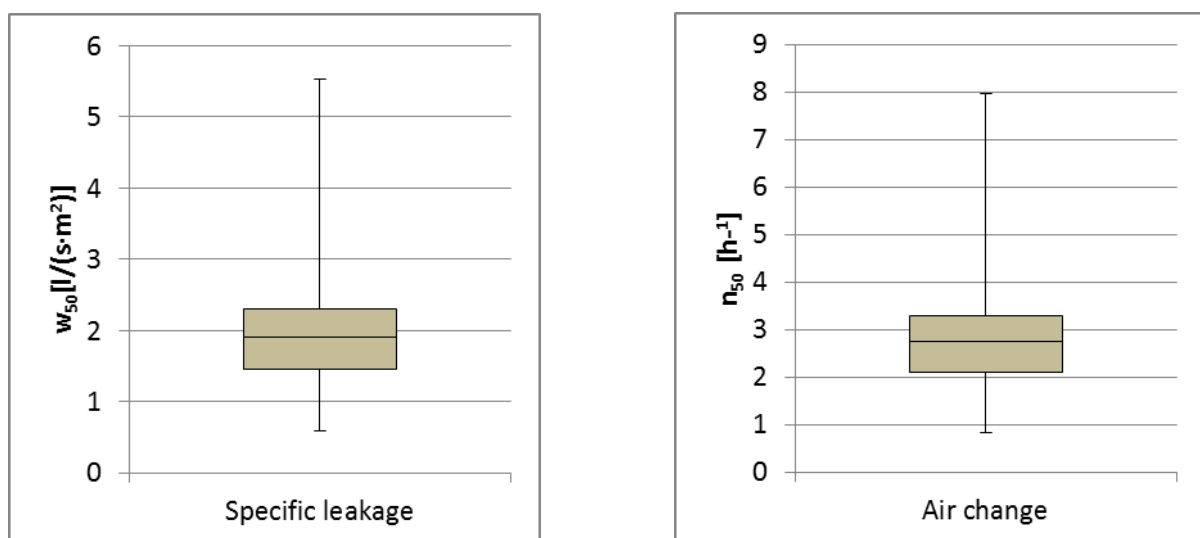
The mean value of specific leakages obtained from Apisseq is $2.05 \text{ l/(s}\cdot\text{m}^2)$ with standard deviation of $0.96 \text{ l/(s}\cdot\text{m}^2)$ corresponding to an air change n_{50} of 2.96 h^{-1} with standard deviation of 1.38 h^{-1} . The distribution can be seen from the box plot in Figure 4. It can be observed that the maximum value, which is the test result of flat 2.20, lies significantly above the 3rd quartile. To eliminate the measurement error we repeated the test next day. The result was only 3% different from the first test. This may indicate an abnormality due to construction problems in this flat. More discussion follows in the Discussion section.

Figure 4. Distribution of overall results of blower door test

The tests have shown, that the average specific leakage of the building is $2.05 \text{ l/(s}\cdot\text{m}^2)$ which would not fulfill the Danish requirement of $1.50 \text{ l/(s}\cdot\text{m}^2)$. Nevertheless 27% of all flats in the building had specific leakage lower than the requirement. This enhances the importance of large portion of flats in one building (even when they are identical) being tested when relevant results are sought.

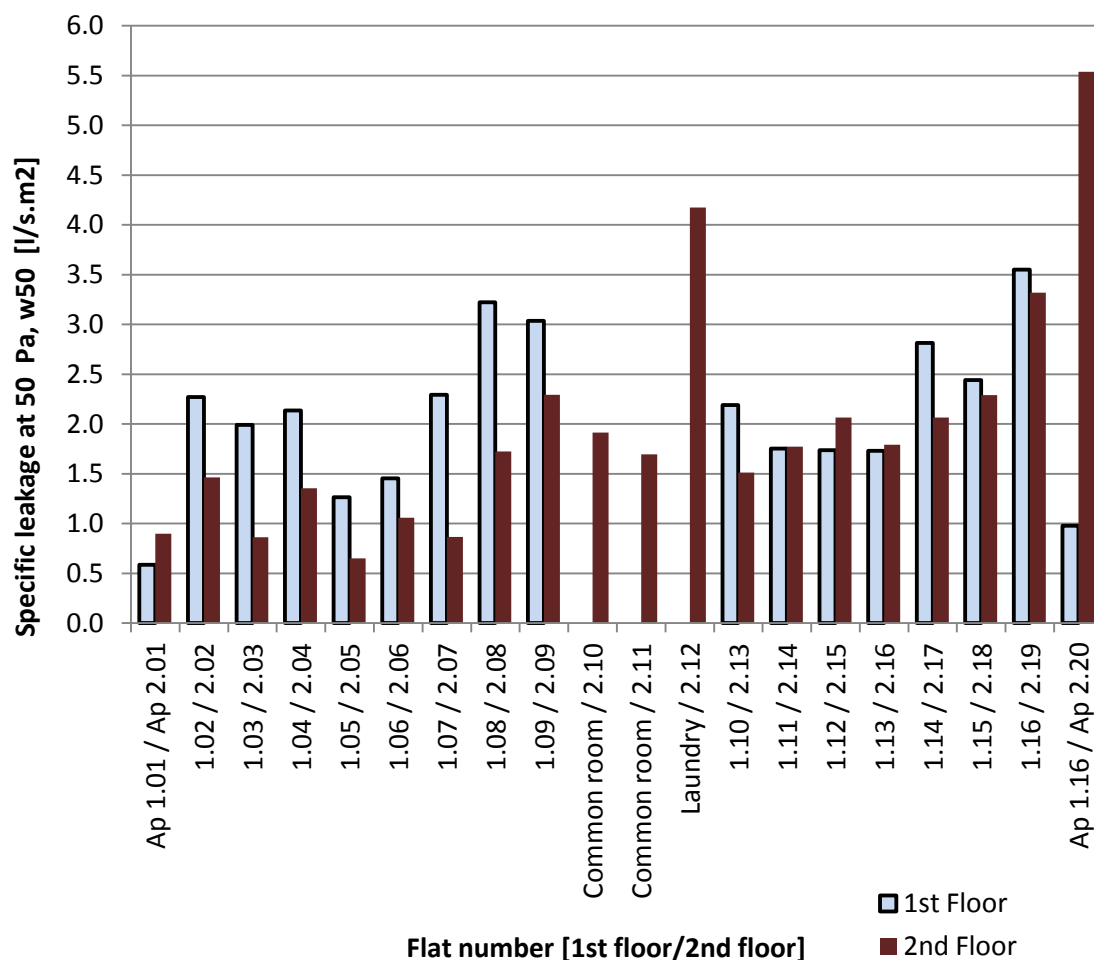
The combined specific leakage in all the tested units is presented in Figure 5. When testing the correlation between the first and second floor by means of Pearson's correlation test, we found a positive correlation of 0.53 at 5% level of significance between the single room flats which are above each other.

Figure 5. Combined results of testing all the units within the student accommodation

The positive correlation between the single room flats above each other could be explained by the horizontal direction of the construction. The degree of dependence is however very low.

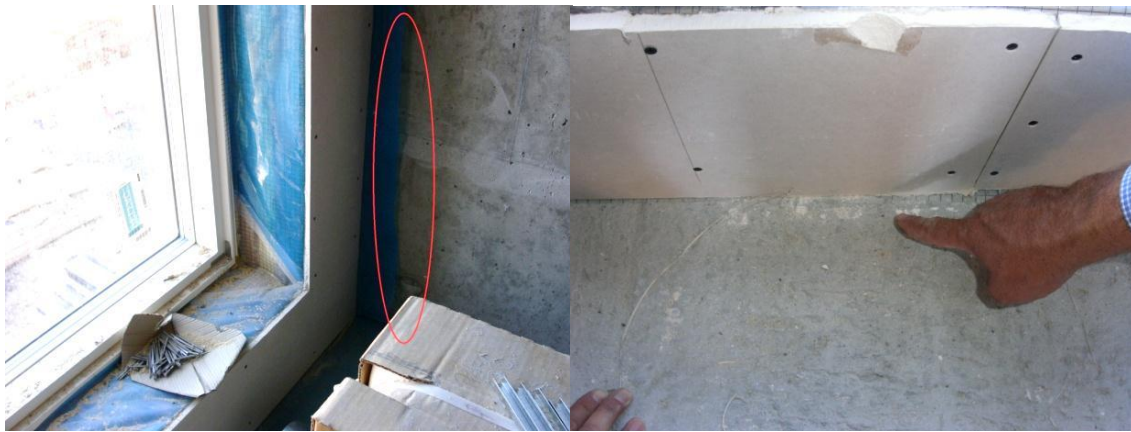
The reasons for poor air tightness are several. The lack of the installation gap between vapour barrier and inner surface plays a large role since all the installations have to penetrate the vapour barrier when entering the flats. Another reason is lack of overlapping flaps in corners where the vapour barrier connects to the concrete walls and floors/ceilings (see Figure 6).

Figure 6. Left: Correct connection with overlap; Right: Missing overlap

We assume that if the blower door test was done during the construction phase, many errors would be explored and fixed which would have positive effect on the final air tightness.
